Monitoring of Miele corporate headquarters Johannesburg, South Africa

ABSTRACT: This paper describes the setting up of a monitoring program to identify and quantify the most significant problems relating to occupant discomfort encountered in a commercial building in Johannesburg, South Africa. It discusses the rationale behind the program and describes some of the problems encountered.

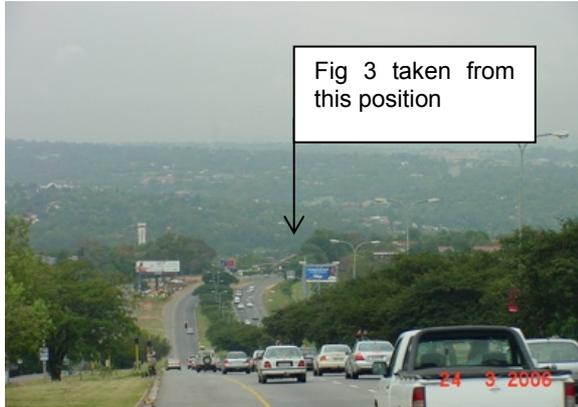
Figure 2: Photo showing the valley in which the building is situated

As can be seen from the photographs fig 2 and 3, the building lies in a valley and its thermal behaviour is probably influenced by the microclimate. There are high trees to the north of the site. Due to the slope of the ground, buildings to the west of the site are higher than the Miele building and may also influence the microclimate. In order to obtain exterior climate data it was decided to install a weather station on the site to obtain site conditions over an extended period of time.

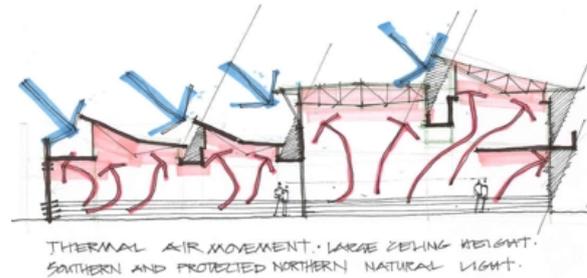
Figure 6: Conceptual drawing showing cooling

4.2 The building was conceived as a “passively cooled and ventilated” building. Whilst these terms are freely used by architects and designers they have different meanings to different people. In this case there seems to have been an acceptance that the ventilation would occur as shown by the diagrams illustrated in figures 6 and 7. No engineer nor ventilation specialist was employed to check or verify that the desired ventilation rates needed to cool the building would be achievable.

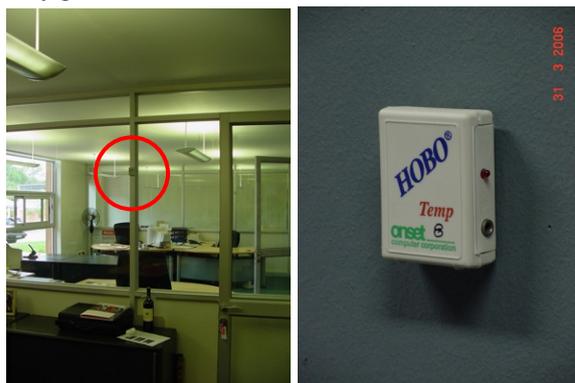
Figure 7: Monitor on mullion

10.1 The Onset HOBO H8 data loggers functioned well and the only problems encountered were that the double sided adhesive tape failed and the loggers fell from their mounted positions. They were picked up by staff and simply placed in any position for e.g. on the balustrade wall in the baking sun and rain. Some data was corrupted by this.

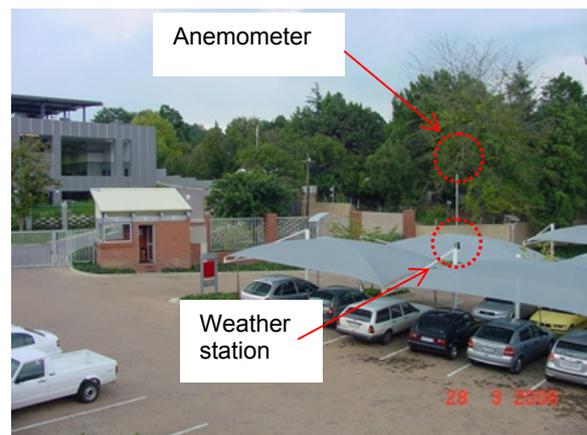
Figure 10: Weather station as viewed from a first floor balcony

weather station and the building itself, indicating air flowing over the paving can pick up considerable heat which is not cooled by the small amount of vegetation in front of the building.
