Environmental Evaluation of an Active Façade in a Naturally Ventilated Office Building

Ian C Ward¹, Haşim Altan¹, J Mohelniková², D Pišek²

¹ Building Energy analysis Unit, School of Architecture, University of Sheffield, Sheffield, UK

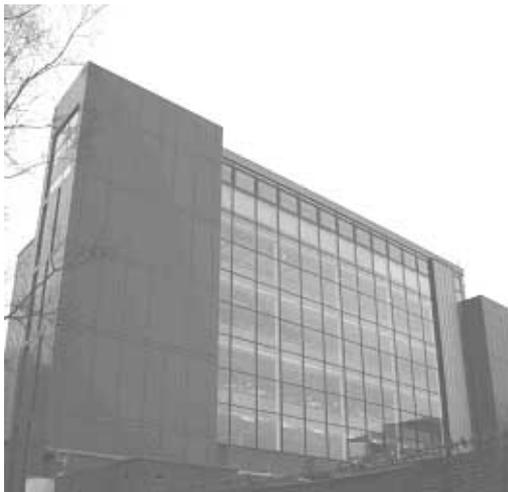
Figure 2: Investigated office building.

The building being investigated was constructed in 2004/05 and uses the 100% glazed south façade as a means of heating the air which then rises and is vented out at the top. The replacement air is supplied via openings on the north façade. Figure 1 shows the design concept for the ventilation regime. Figure 2 shows the south façade of the building and the internal shading devices. The initial monitoring of this building was aimed at establishing if the south façade was operating as expected with respect to drawing the air through the building and that the lighting of the work spaces was appropriate.

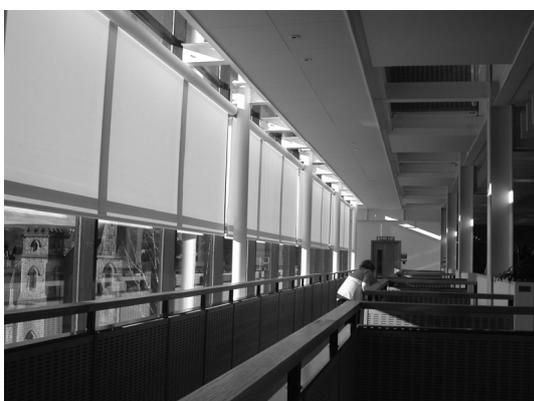
From the measurements shown in table 1 the space seems to be adequately lit. However the design of the blind system on the south façade resulted in gaps being seen between the blinds on different floors (see figure 4). These gaps allowed sunlight to penetrate in narrow shafts to the working positions and there was some evidence from some of the occupants that they found this situation disturbing. Therefore measurements of the luminance distribution at various locations were carried out.

Figure 4: The blinds on the south façade.

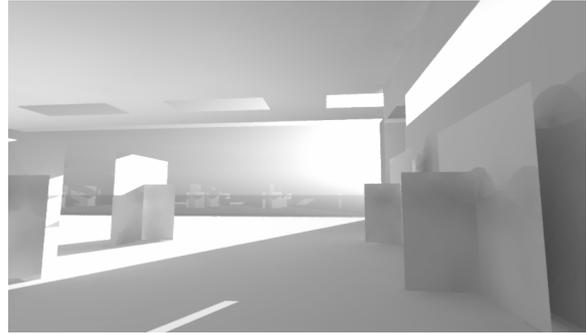
Figure 8: Luminance distribution at working position 1 looking south.

These simulations clearly demonstrate that there is wide range in brightness's within the working environment, which may cause visual discomfort to occupants.
