# Design and Evaluation of a Low Carbon Emitting Naturally Ventilated Student Health Centre

**ABSTRACT:** The new Student Health Centre at the University of Sheffield has won two prizes at the annual Royal Institute of British Architects' (RIBA) Yorkshire Awards 2005. This building was designed specifically to be naturally lit, incorporate an energy efficient natural ventilation system and the use of environmentally friendly components and finishes. This paper outlines the method by which the design was developed and implemented. After completion, a post occupancy analysis was carried out and aimed at determining the effectiveness of the design brief with respect to the design aspirations. This analysis involved monitoring internal conditions in specific rooms and carrying out a walk round survey to determine the users reactions and window opening strategies.

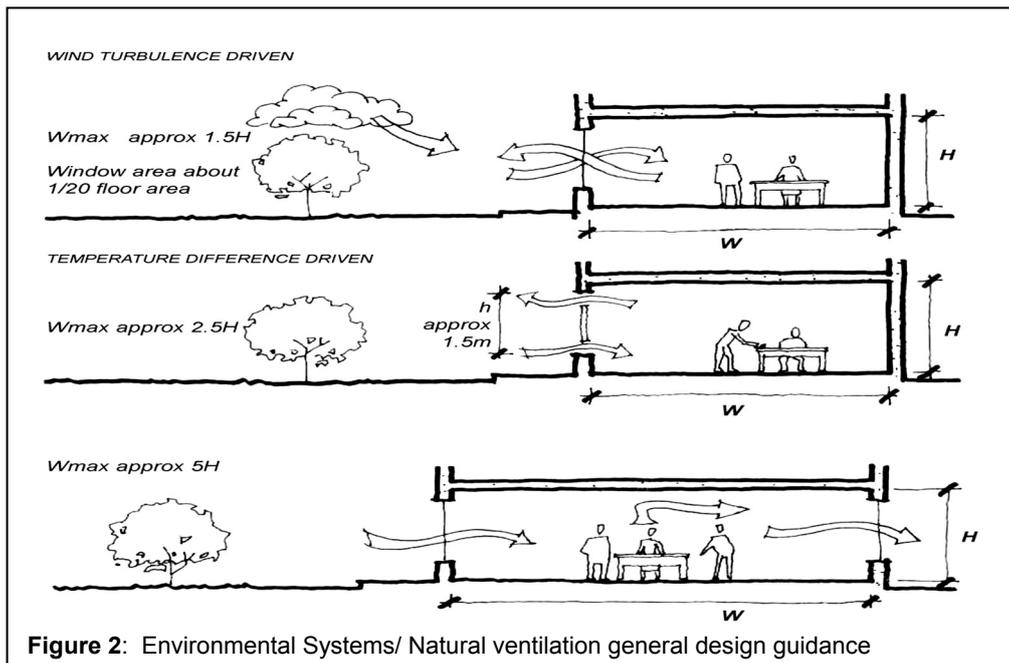
Figure 2: Environmental Systems/ Natural ventilation general design guidance

To ensure that the above targets are delivered a Project Management Team oversaw the project: Environmental systems/Natural ventilation was specified; window openings and room depths designed according to BRE [4] published information (see figure 2).

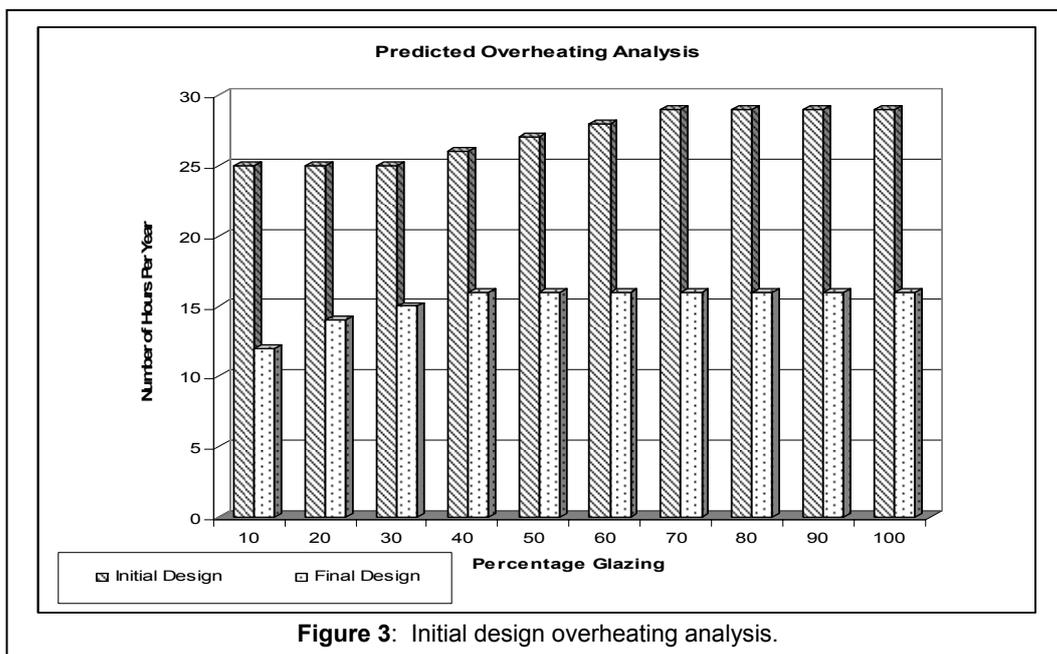
Figure 3: Initial design overheating analysis.

During the initial stages of the design, the overheating potential of the building was of major concern and steps taken to minimise the occurrence. This was carried out by running the EU developed LT for Europe [5] simulation programme and modified outputs for it are shown in figure 3.

This analysis demonstrated the value of providing night cooling which was then taken on board by the designers of the building.

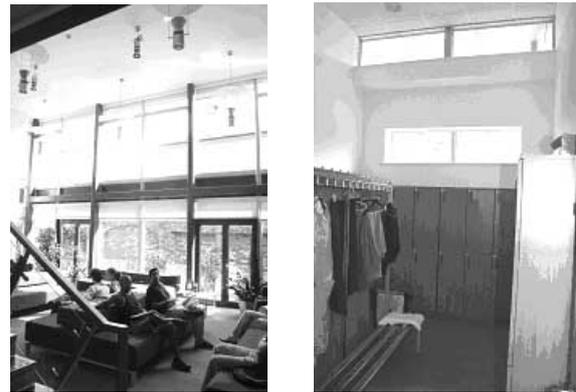
**Figure 6:** Left: Waiting area, Right: Changing room.

**Figure 6** The waiting area of the health Centre is a double story height space with plenty of openable windows at both levels. However the openable windows at the top of the space were not automatically controlled and therefore there was no way in which they could be opened. The ones lower down were automatically controlled. The changing room again had two levels of windows, the top level were on automatic controllers but the lower ones were not, however, due to the position of the furniture staff could not reach the to open them.

The measurements taken, and the computer simulations carried out indicate that although the building suffered from some overheating problems, due to lack of air movement, there is the possibility to rectify the situation by; installing automatic controllers on the high level windows and install sound proof air transfer grilles above the doors to the surgeries.

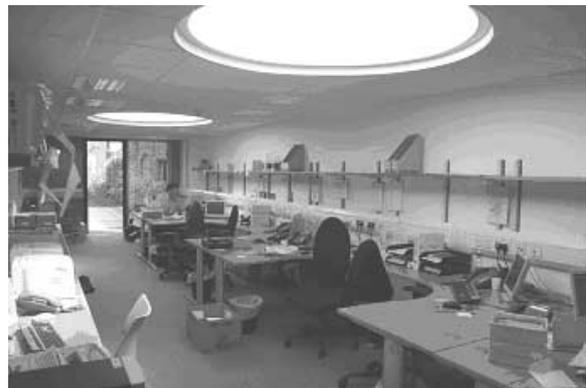
**Figure 7:** Light domes.

**Figure 7** This is a long narrow administration space which has roof lights which provide a good distribution of daylight, however, the natural ventilation provision is via the door at the end of the space.

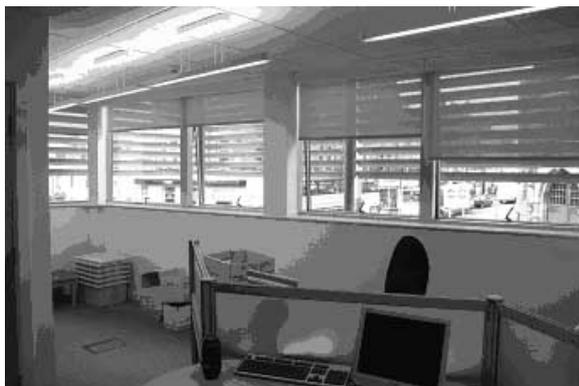
**Figure 4:** Windows with normal operation.

**Figure 4** Illustrates the attempts made to shield the west façade from afternoon sunlight - this has severely restricted the view out of the windows but the average daylight factor was measured at 7% which is above the standards required [3]. The windows were opened manually to provide extra natural ventilation.

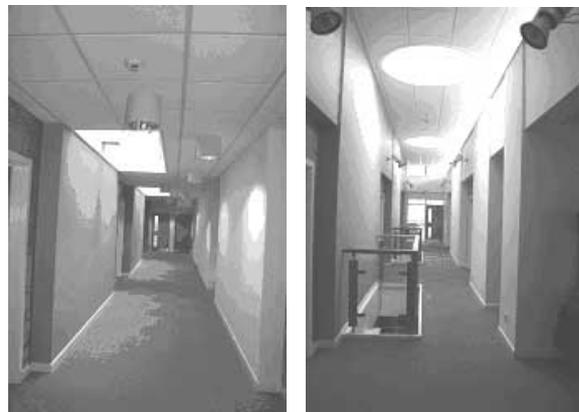
**Figure 8:** Ground and first floor hallway.

**Figure 8** This figure shows the access corridor to the doctors' surgeries, the intention of the designers was to use clearstory lights as a high level extract route for air. The supply air was to be via the doctors surgeries. The vertical stacks from ground floor to first floor are clearly visible in the right hand photograph. However due to acoustic privacy requirements of the surgery rooms extra seals were positioned on the doors which reduced the ability of air to move from the surgery to the corridor. Natural ventilation transfer grilles above the doors were omitted for the same acoustic reasons.

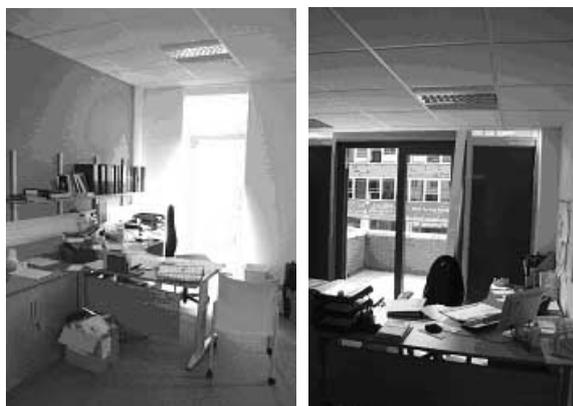
**Figure 5:** Left: Consulting room, Right: Office.

**Figure 5** Shows a consulting room and an office space on the east façade, both of which have high glazing ratios thus providing good daylight quality. However the office space does not have openable windows and natural ventilation is provided by opening the door - clearly not a good design solution in cold and wet weather. The consulting room has very good daylight but the large window detracts from privacy when examining a patient and therefore the internal translucent blinds are permanently closed which has detrimental effect on both the daylight quality and the natural ventilation potential.

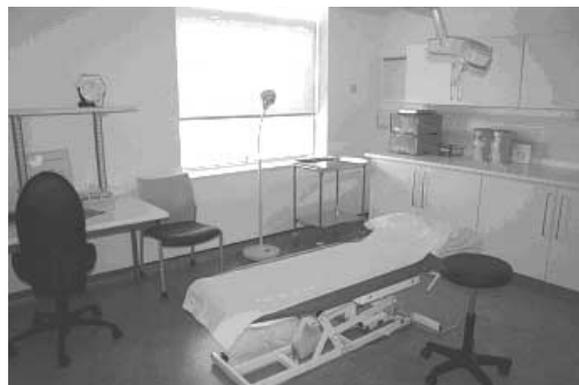
**Figure 9:** Operation room.

**Figure 9** Again daylight and ventilation requirements are compromised by privacy concerns.

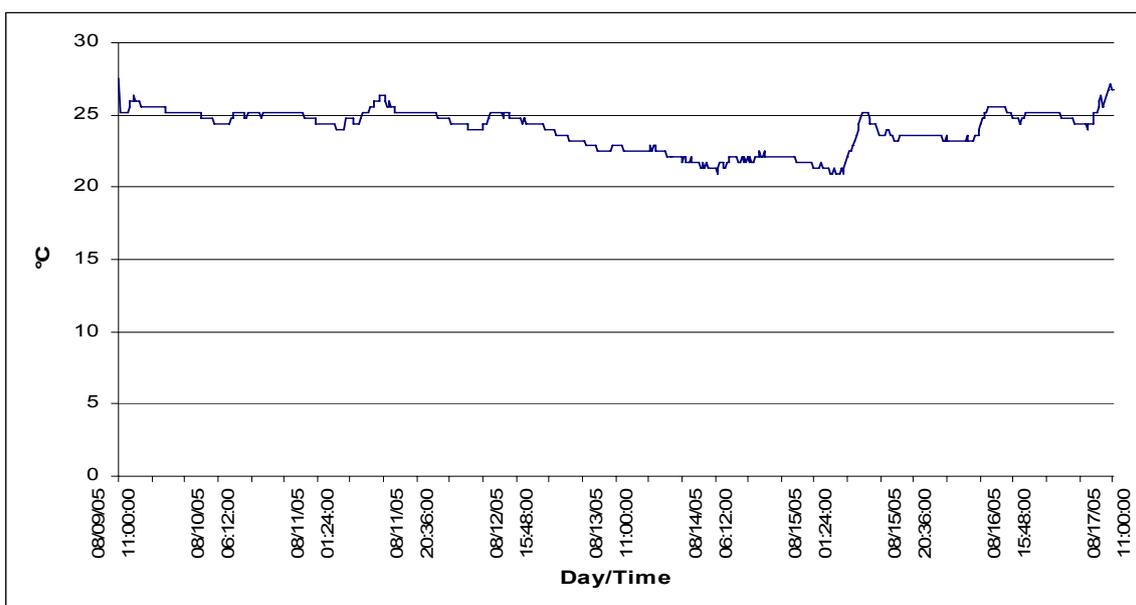
Figure 10: East facing Office space temperature 9<sup>th</sup>-17<sup>th</sup> August 2005

internal conditions of temperature, humidity and lighting levels. Figures 10 and 11 illustrate some of measurements taken highlighting that in these two spaces there was a degree of overheating.

From the monitoring exercise there appeared to be some spaces which suffered a degree of overheating in July and August. This was primarily caused by a lack of control over the natural ventilation strategy. No information was given to the occupants about how to ensure that night ventilation could 'cool' the fabric thus delaying the build-up of temperature in the rooms.

It would also be recommended that the staff were issued with an operating manual outlining under what conditions the windows should be opened.

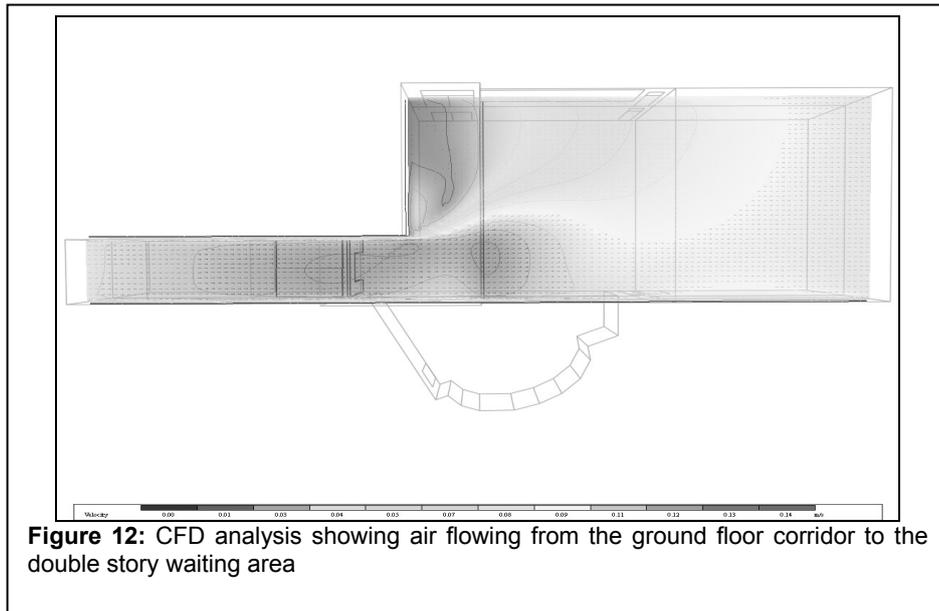
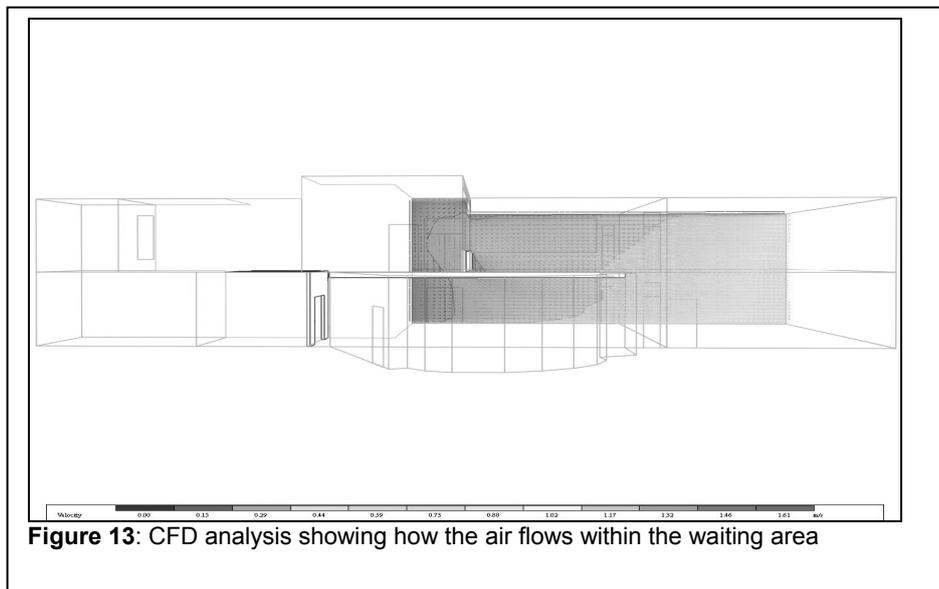
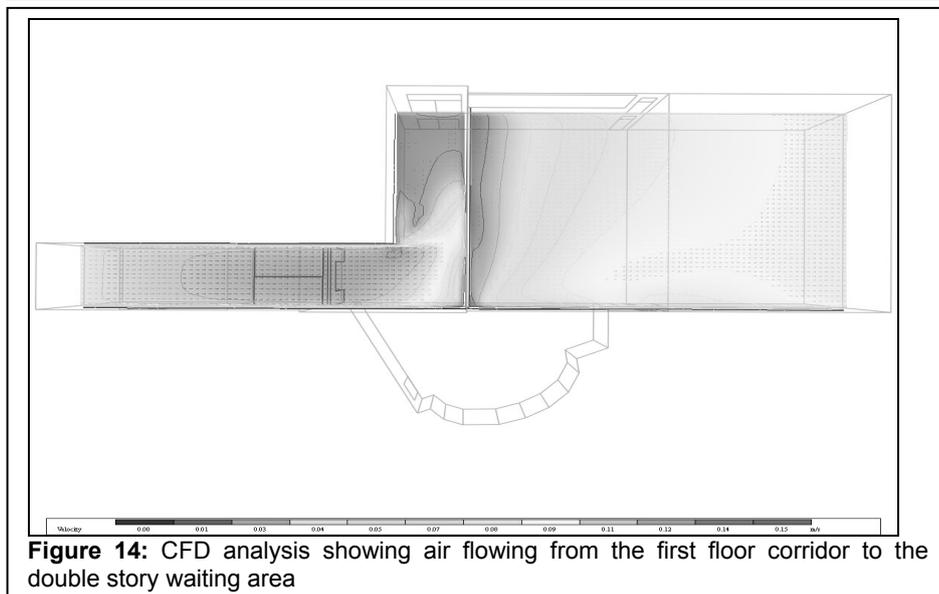
The problems highlighted in the lack of natural ventilation caused by a failing of the window opening strategy were of concern to the operation of the building. One area of particular concern was the waiting area and this part of the building was modelled using the CFD package within the Integrated Environmental Solutions software package [8].

The results of this analysis indicated quite clearly that it would be possible to provide adequate natural ventilation during warm periods. Sample outputs from the simulations are shown in Figures 12.13 and 14.
