Urban Environmental Glare: the Secondary Consequence of Highly Reflective Materials

ABSTRACT: This paper examines the impacts of the choice of building materials on the immediate surroundings by examining a case study, the Walt Disney Concert Hall by Frank Gehry, in downtown Los Angeles. The building apparently increased surrounding ground surface temperatures to 60 C and lightweight freestanding surfaces reached temperatures as high as 170 C (enough to melt some plastics.) Surrounding neighbors complained of increased temperatures within their buildings and visual glare. There was also visual glare in surrounding traffic intersections.

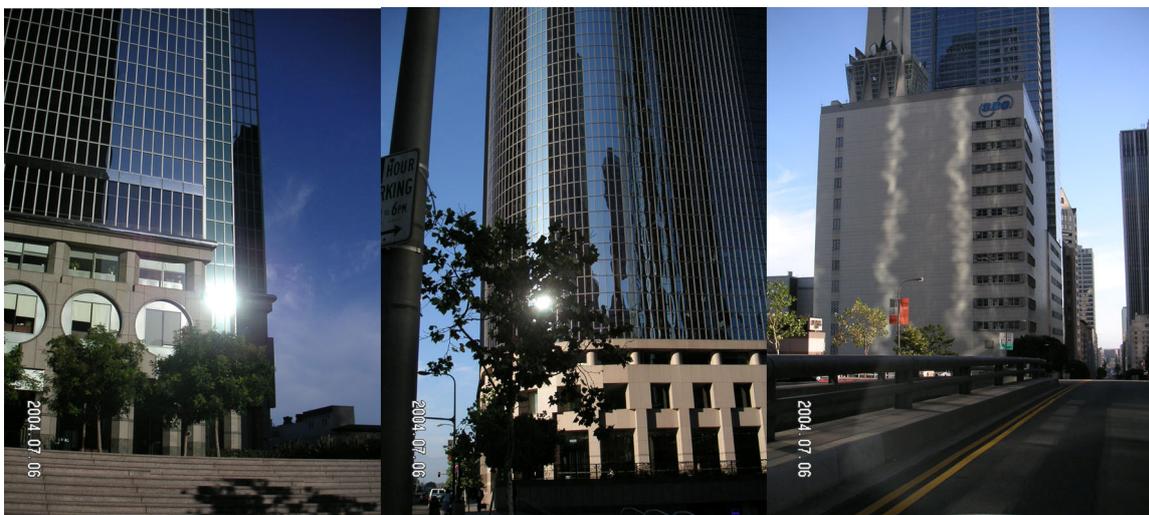
Figure 1: Crocker Bank, Deutsche Bank and reflection of Deutsche Bank onto neighbouring building

While changing the albedo or reflectance of the roof surfaces may reduce the heat island, the only demonstrable reduction has come from reducing the amount of exposed construction material, such as concrete and asphalt. Vegetation, which converts sunlight (short wave radiant gain) directly into plant mass, is the only alternative known to be effective, as long as there is sufficient moisture to keep the vegetation alive and allow evapotranspiration to limit sensible heat gain and temperature increase.[1] Similar buildings abound in most downtown areas. See figure 1.

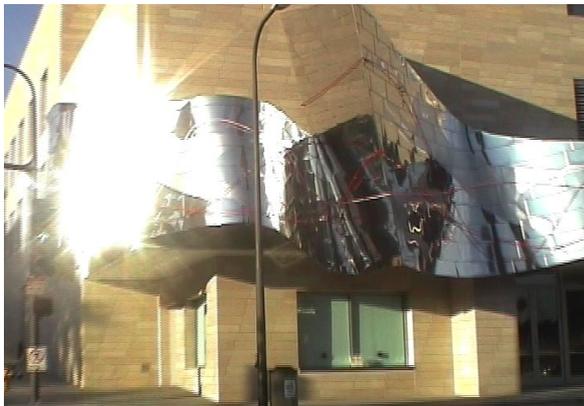
Figure 2: Reflection from REDCAT marquee

The building is visibly reflective, especially in the area of the Founders Room and the Roy and Edna Disney California Arts Theater (REDCAT) marquee. See Figure 2.

Both of these portions of the building use a polished version of the stainless steel, which has a reflectance similar to the brushed stainless of the rest of the building, but a much greater specularity.

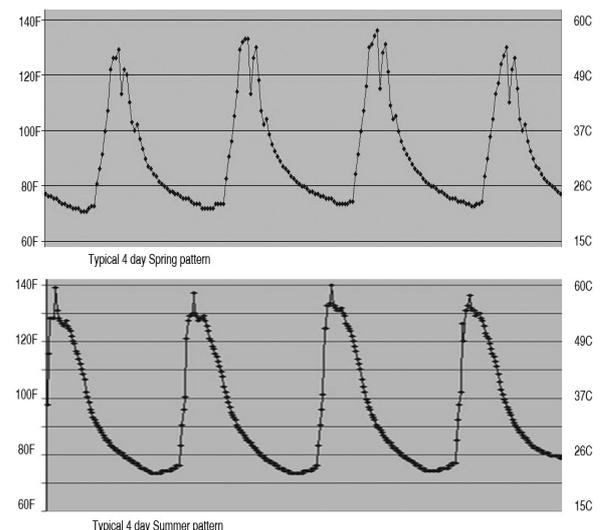
Figure 3: Four typical days in Spring and Summer

To observe thermal behavior, Dallas/MAXIM iButton dataloggers were embedded in the surface of the concrete to the south of the building in areas where concentrated beams of reflected sunlight were observed to pass through. These recorded values every 30 minutes for two week periods around both solstices and equinoxes.

The dataloggers showed that ground temperatures regularly attained 60 C (140 F). See Figure 3.

Other information became apparent, as well. The equinox values showed a different behaviour than the summer values. Upon further inspection of the site, it was found that there was a building which was shadowing the marquee at certain times of the day, during the equinox, which cut off the sun and thus also cut off the reflected and focused beams.

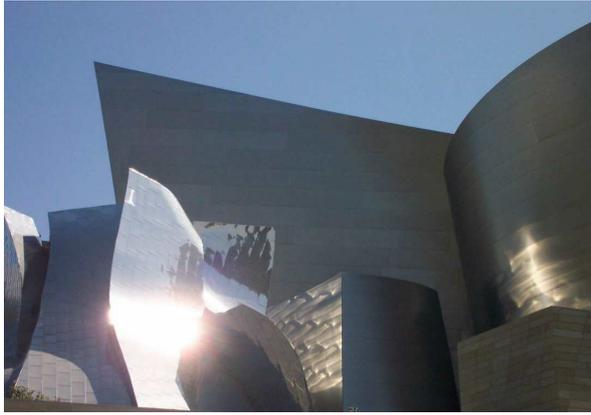
Figure 4: Photograph & Simulation of WDCH

To observe visual glare, photographs were taken and analyzed for glare and then computer simulations were performed for the remainder of the year, to anticipate similar glare in various locations around the building. See figures 4 and 5.

The building was simulated from each intersection and three other critical locations at both solstices and equinox at half hourly intervals. See figures 4 & 5. Simulations were color coded. Absolute values in excess of 12,000 cd/m² were flagged in red so that they could be easily picked out in a visual survey and clearly delineated for corrective action. See Figure 7. Surfaces which resulted in focal points well above the

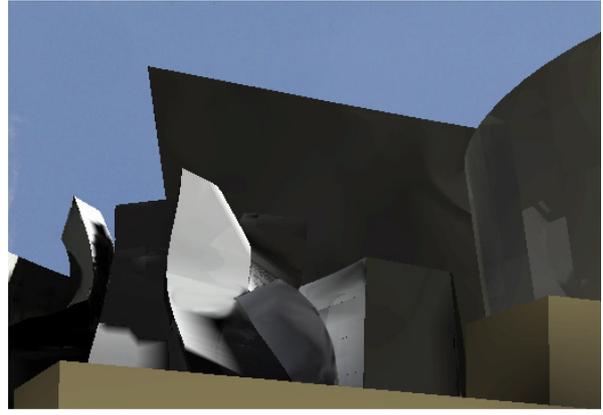
Figure 5: Simulation of WDCH

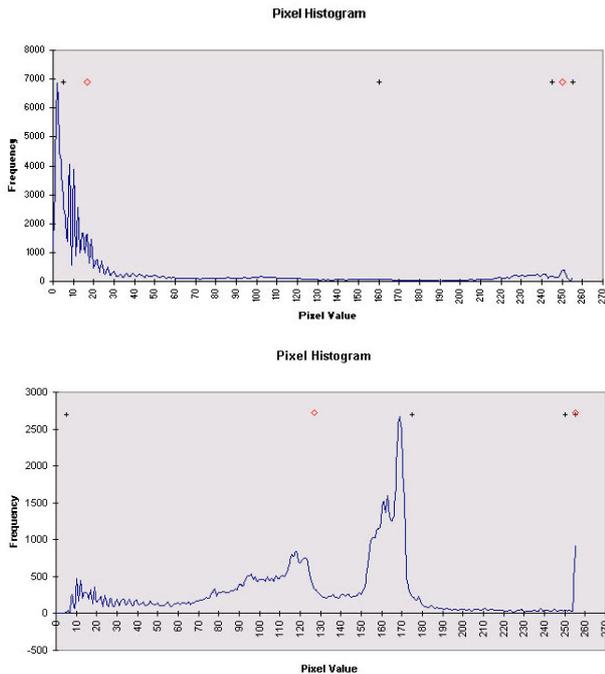
Figure 6: Histogram of relative pixel intensities distributions showing glare (above) and no glare (below) conditions.

In a new process developed by Schiler, Japee, Tedjakusuma and Culp the histograms of the photographs were analyzed to determine if the ratio of peak luminance to background (adaptation) luminances was indicative of glare.[3, 4, 5] See Figure 6. The analysis consistently showed that luminances in excess of 12,000 cd/m² were problematic.

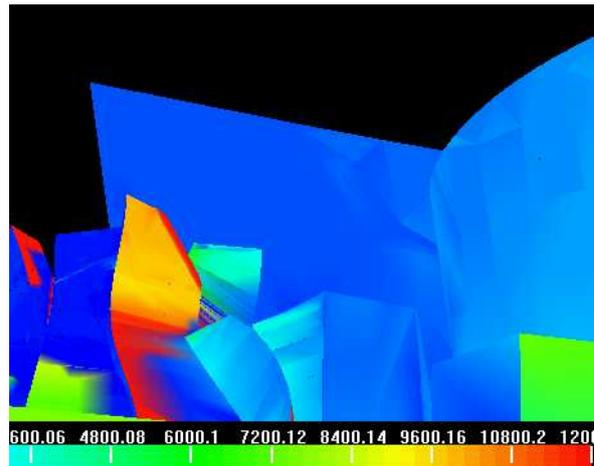
Figure 7: Isolux plot w/ 12,000 cd/m² flagged in red (in original)

Six surfaces on the Founders Room were deemed unacceptable. Most of the marquee proved to be unacceptable at one time or another. The other surfaces were either above the field of view or did not focus radiant energy in an occupiable area..

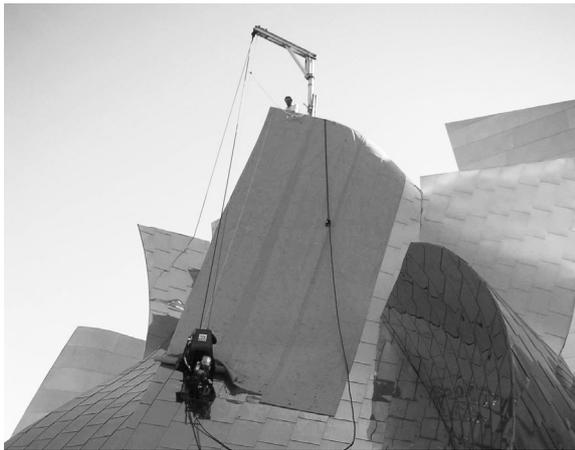
Figure 8: Fabric wrapped over offending surfaces

Three of the six surface films tested were found to be acceptable and one plastic fabric of approximately the same color as the steel was also acceptable. It was decided to use the fabric as a temporary solution, draped over the critical surfaces. This allowed verification that all critical surfaces had been accounted for, while further tests were conducted and the first season of the symphony commenced. See Figure 8.

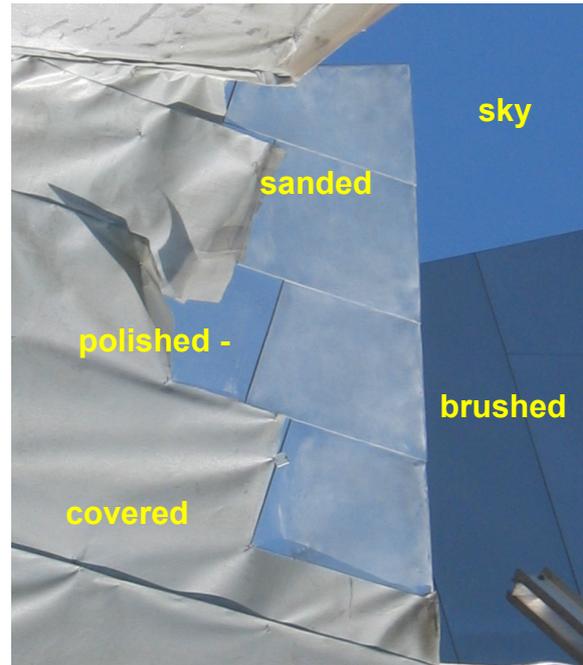
Figure 9: Fabric, sanded, brushed and polished surfaces against sky

The original polished stainless steel and the original brushed surface (“Angel Hair treatment”) and four alternatives were tested using a Rhopoint gloss meter at a 60° degree angle from the surface and at a 20° angle from the surface. See Table 1. The greatest benefit in shallow angles came from the 220 Grit vibrator sanding and 100 Grit at steeper angles. The vibrator sanding was used as the base treatment. For aesthetic reasons, orbital sanding was done in addition to the vibrator treatment. The final treatment sanded all panels which had been determined to be sources of glare. See figure 9. Because of the geometries of the curved surfaces, it was often the case that only a portion of the surface needed to be sanded. In such cases, the cutoff for sanding was often a diagonal line, so the resulting sanding resulted in interesting stair-step patterns on the façade of the building, but resulting from naturally harmonic patterns instead of random placement. See Figure 10.

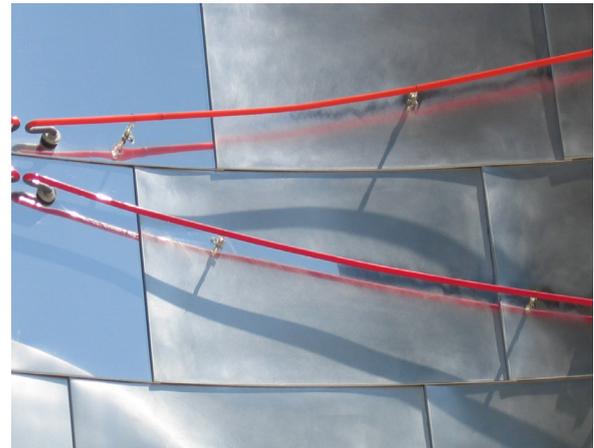
Figure 10: Sanded panels next to polished panels in diagonal stair step pattern
