Thermal rehabilitation: assignment of balconies into conservatories; the 'Libellules' case study

Reto Camponovo, Jean-Yves Magnin and Peter Gallinelli

LEEA, Laboratory Energy Environment Architecture,
EIG Ecole d'ingénieurs de Genève Hes-so, Geneva, Switzerland

This paper will discuss a recent case study of a big building complex called the 'Libellules' in a suburban region of Geneva.

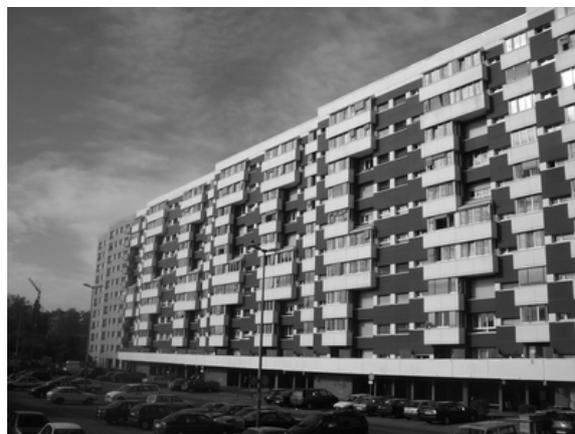
Figure 1 : The "Libellules" block in its actual state (sight of the southern wing).

Figure 1 shows the building in its actual state. The old balconies, now closed are easily recognisable by a colour coding on the level of the facade, as they are painted white.

Initially the building was of a prefabricated modular construction on the system « Balancy » and its walls were composed (from inside to outside) as follows: 1 cm rough-coat or tiling, 5 cm of concrete, 4 cm of cork, 12 cm of concrete, which gave a pretty weak thermal performance which was nevertheless acceptable at the time. The IDE was 610MJ/m².K (final heating energy)

The facade had 10 cm of glass wool isolation added to it in a ventilated construction system glazed on the exterior by fibrolite plates.

In addition all of the balconies were simply closed with the placing of windows of a good thermal performance for the time ($U=2,7 \text{ W/m}^2\text{.K}$). The old balcony walls in 10 cm ferro-concrete were naturally also refacaded with the same system as the rest of the building.

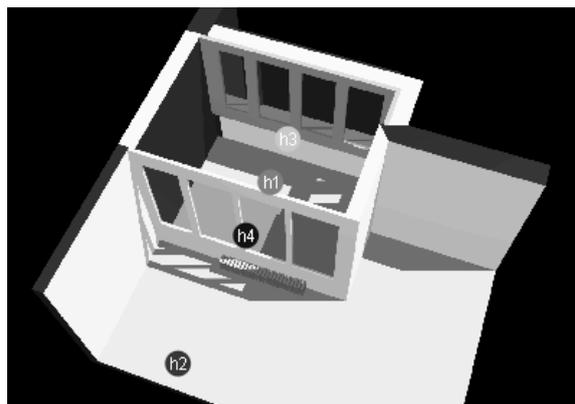
Figure 2: Measurements locations in "balconies-loggias".

In the case of smaller loggias these become an extension of the living room notwithstanding the presence of the old window separating the apartment from the balcony as it once was (see fig. 2).

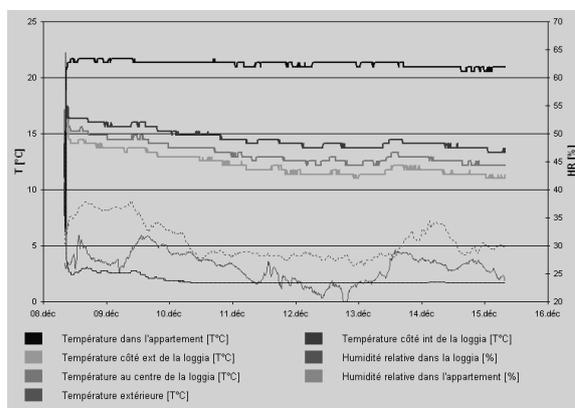
Figure 3: Hygrothermal data profile in different measurements points.

In winter conditions with a weak sunshine factor measures consistently showed a loggia temperature 8 or 9 °C below that in the interior of the apartment. Predictably both measurements and careful calculations using a modelisation of the construction elements frequently show interior surface temperatures below dew point. These observations, related to the manner in which the space is used suffice amply to explain the presence of surface condensation at the interior of the loggias.

In summer, on the other hand, and this applies particularly to the loggias with the maximum exposure to the sun, interior temperatures can peak well above 38 °C, above all in view of the defective solar protection blinds.

We can therefore conclude that this "hybrid" space created by the suppression of the balconies is not suitable as a living space, and that any attempt to make the interior space of the apartment reasonably comfortable, the thermal buffer effect must be used diligently as seasons change. This means that thermal flux between the interior and the exterior space would have to be controlled by a modulation of the passage through the loggia.

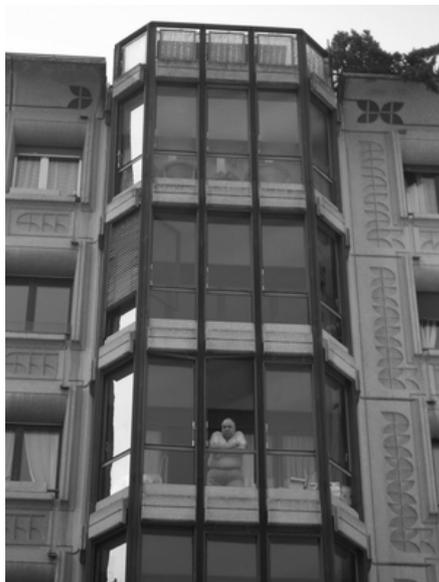
For this reasons the closure of balconies is often realized in a summary way, with the owner or architect making abstraction of the fact that a perfectly adequate old balcony will become an integral part of the living surface. Window frames and panes of inferior quality and an absence of ventilation systems, coupled with an inappropriate use of the space will quickly reveal it to be unsatisfactory to the tenants.

Figure 4 : Recently built housing block. The balconies were closed at the time of building. After 3 years of normal use, the first damage to the interior of the loggia due to condensation have appeared.

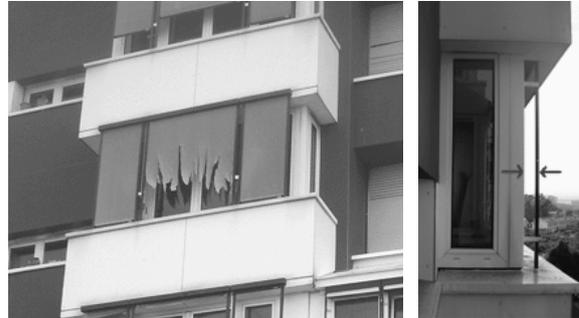
As far as the canvas awnings for solar protection are concerned a wind study has shown that the two principal facades of the building are in an orientation which exposes them to the strongest prevalent winds.

The tearing is all the more accentuated as the distance between the surface and the glass pane is rather large and there is no lateral protection so that the wind easily gets between the layers.

Figure 5 : Detail of a transformed balcony in a bow-windows and sight of solar protections in fabric torn.

This would entail the isolation of the walls on the interior and the suppression of the old windows, now inside the building, the replacement of the canvas blinds with a metallic Venetian blind system which is closer to the exterior surface of the windows with the addition of lateral elements of protection against the dominant wind. This solution had the additional advantage of suppressing the ambiguity of the intermediate space in making it clearly part of the sitting room.

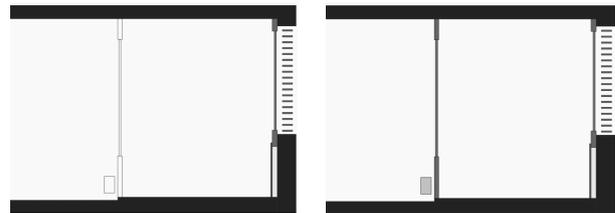
Figure 6 : suggested solution with unambiguous position concerning intermediate space.

alternative solution without ambiguous position from the intermediate space and not solving with certainty comfort in space.

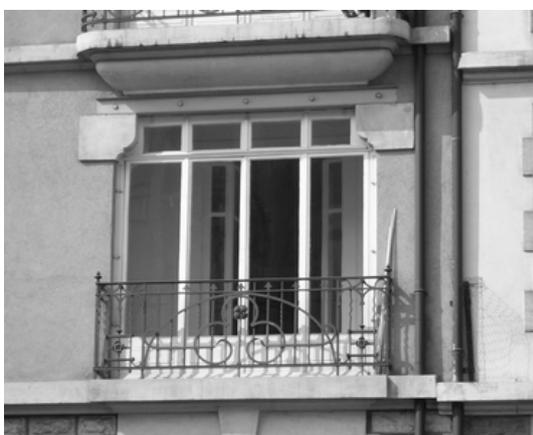
In buildings of a certain rank the balcony can be absorbed in the apartment still allowing for the same functions with a better protection; such space would be called a "loggia".

Figure 7 : Geneva detail of a loggia in a XXth century building.

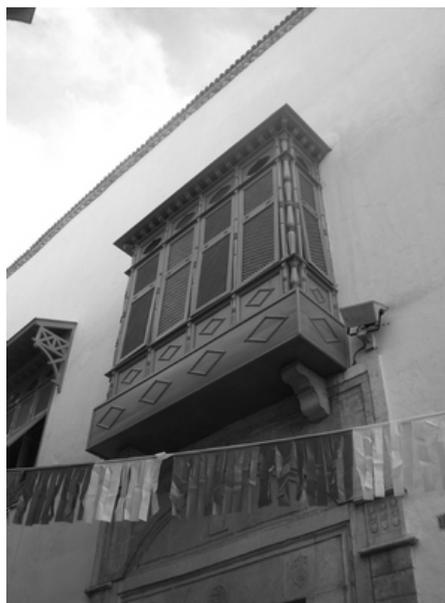
In some southern countries oriels are equipped with special devices of visual protection allowing the inhabitants to look out without being seen. These shutters and screens also serve as generators of shade and as ventilation slats.

Figure 8 : Tunis, the Médina. Traditional Oriel.

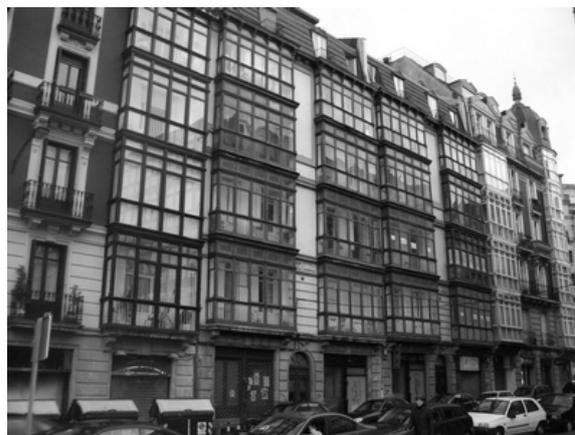
In many Mediterranean countries balconies on buildings exposed to the wind are often protected by structures not unlike bow windows. The depth of the space created is reduced to 60 or 80 cm.

Figure 9 : Bilbao wind protection screens over balconies.

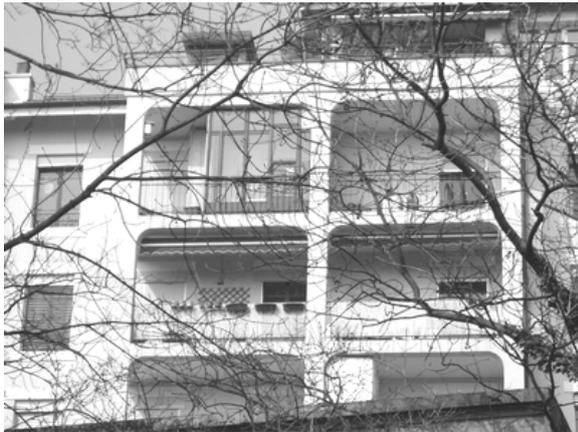
The first case, illustrated in fig 10 was found in a building of the XXth century and represents a « hybrid » intervention in which only a part of the original balcony has been closed off. In this case, taking into account the privileged viewpoint the balconies offer, the space created, even in its reduced dimensions has become a genuine prolongation of the living room, both in summer and in winter.

Figure 10 : Geneva. Detail of a sheltered and partially enclosed balcony in a XXth century building.

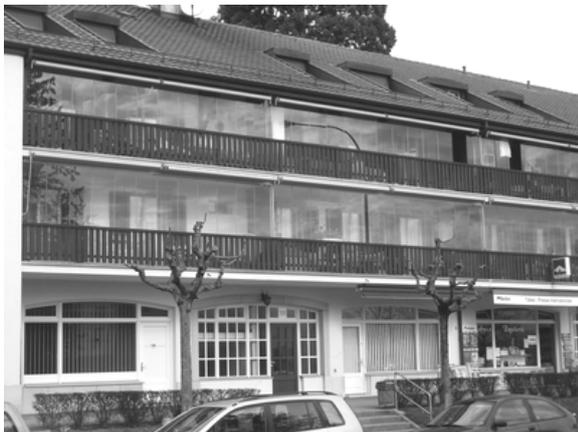
Figure 11 shows an intervention on a building of 1960. It comprises the placing of sliding glass plates which can be easily moved and stocked at one end of the balcony space. This type of intervention was imposed by acoustic as well as thermal criteria; the facade of the building is next to an important traffic route, and exposed to strong winds from the lake just across the street.

Aesthetically and functionally this is a particularly interesting intervention. The glass plates give the façade a certain lightness and leave the initial aspect of the building intact. Not a single structural element is apparent in front of the balconies, the glass plates are suspended from an overhead rail. A fine adjustment of the glass panes and their relative movement allows for a weatherproof and soundproof facade when all of the elements are closed.

Figure 11 : Bellevue, Geneva, Sliding glass panels over balconies on a mid XXth century building.

The glass facade is very easily adjusted which allows the inhabitants to interact with their environment on a virtually daily basis making the space sometimes a balcony and sometimes a bow window.
