Summer Thermal and Daylighting Conditions in 19th Century Traditional Buildings of Florina in North-Western Greece

ABSTRACT: The aim of this paper is to explore the summer thermal and daylighting conditions in traditional buildings of Florina using a typical house. The issues of thermal and visual comfort are approached from two distinct viewpoints: in-situ measurements and computer analysis. The temperature measurements were conducted in the main living spaces of the two levels of the house, throughout the summer using dataloggers. The computer thermal analysis was performed with the Ecotect software. The results of the computer analysis are compared with the recorded air temperature measurements. The daylighting measurements were conducted in the main living spaces of both the ground floor and the upper storey, on a date near the summer solstice at 09:00, 12:00 and 15:00 TST. The daylighting analysis and simulations were conducted using the Ecotect and the Radiance software. The results of these two approaches are compared.

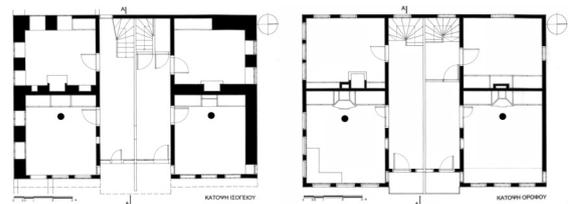
The house has an eastern orientation. It is a large mansion with inner *sofa* of the 19th Century and is characterised by heavy mass construction (60-cm thick stone walls) on the ground floor, except for the main façade of the building. (Fig. 1) The upper storey is constructed with lightweight wooden frame walls filled with adobe bricks (*tsatmas*). The thermophysical characteristics of these walls are presented in [1], [2].

Figure 1: Ground and upper floor plans of the house with eastern orientation.

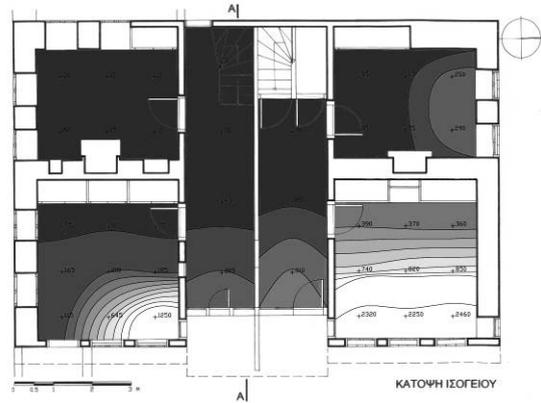
At 09:00 TST (10:35 LCT), daylighting conditions in the main living spaces of the ground floor were good, whereas in the secondary rooms, the conditions were poor (Fig. 10). The minimum value for the south-eastern main living space was 75 lux,

the maximum value was 1250 lux, and the average was 310 lux. The minimum value for the north-eastern main living space was 360 lux, the maximum value was 2460 lux, and the average was 1175 lux. The average value for the south-western secondary living space was 25 lux. The average value for the north-western secondary living space was 125 lux.

Figure 10: Ground floor. Daylighting measurements at 09:00 TST.

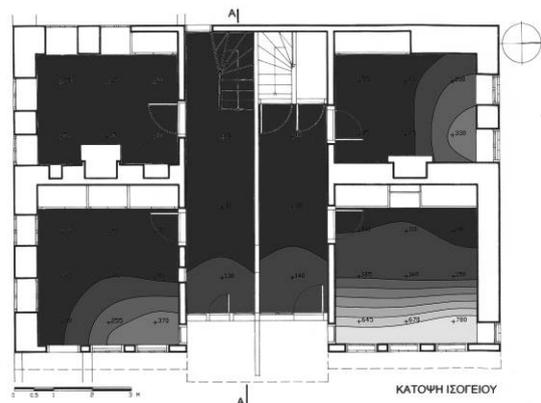
At 12:00 TST (13:35 LCT), daylighting conditions in the main living spaces of the ground floor were good, whereas in the secondary rooms, the conditions were poor (Fig. 11). The minimum value for the south-eastern main living space was 30 lux, the maximum value was 370 lux, and the average was 115 lux. The minimum value for the north-eastern main living space was 80 lux, the maximum value was 780 lux, and the average was 320. The average value for the south-western secondary living space was 30 lux. The average value for the north-western secondary living space was 120 lux.

Figure 11: Ground floor. Daylighting measurements at 12:00 TST.
