411: Thermal characteristic of building envelope in revitalized post-industrial buildings.

Dariusz Heim

Technical University of Lodz

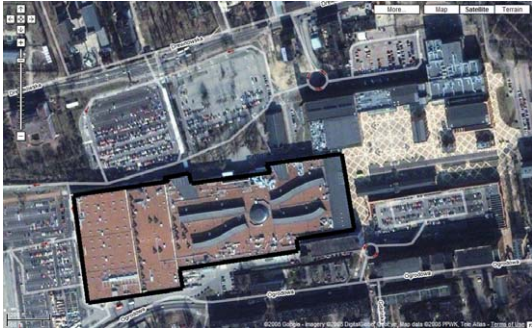
Fig 2. Manufaktura complex – bird's eye view.
(source: <http://maps.google.com>).

The revitalisation is not only the protection but sometimes is connected with adding a new elements to the empty ground (Fig.2) (bold line indicates the new building covering the valley). These actions leads to crowding of buildings in city centre, limitation of green spaces and the significant changes in building arrangements. In analysed case the old factories were located on the river's valley. The valley enabled fresh air to ventilate the city. When the new buildings arisen on the spot of the river bed the local microclimate were change considerably. It had a significant influence on climate both in urban and local scale. Buildings blocked the wind flow entering to the city and weaken the ventilation. On the other hand in the dense urban structure local zones with high wind speed and vortices appeared. In some locations buildings were exposed to the strong wind what could has influence on their thermal behaviour and surroundings.

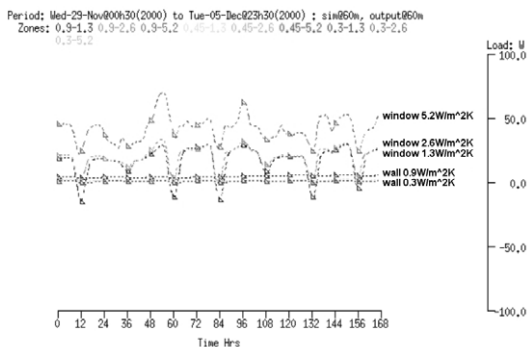
Fig. 5. Convection heat flux through the wall and window (commercial building).

The analysis were done for the selected week of winter. The ambient temperature changes from +1°C to -15°C. The control system was defined as a constant heating, lower power out of occupancy period and no control out of occupancy period. The results presented in figure 5 and 6 represents the heat exchange by convection (fig. 5) and temperature (fig. 6) history for commercial building. The substantial fluctuations of both parameters are noticed for windows where heat gains during some days gave positive values of heat balance. On the other hand during the night the heat losses by the windows are 10 times higher than by the masonry wall. The massive structure of the wall allows to keep constant heat flux (constant zone's temperature) but the temperatures varies very deeply between day and the night.

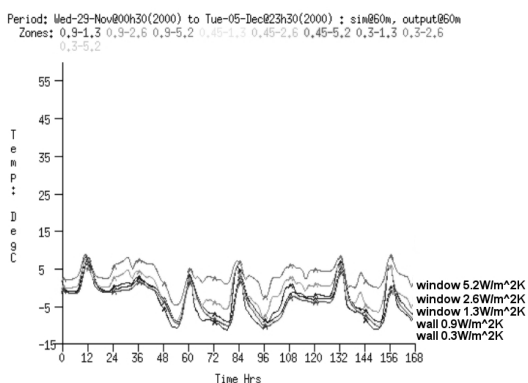
Fig. 6. Temperature of external surfaces, wall and window (commercial building).

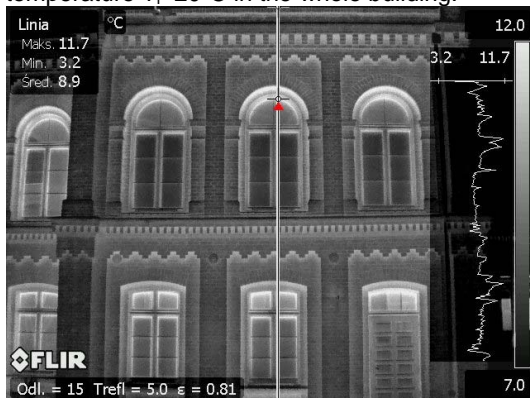
Fig. 9. Results from infrared camera – vertical temperature profile along the elevation.

The selected results of IR measurements are presented in figures 9 and 10. The effects of complex physical processes described by

numerical simulations are also clearly seen on thermovision images. The warmer areas are noticed in the hollows under the sticking elements. It is effect of:

- lower wind flow in deeper spaces thus lower convection heat exchange,
- different thickness of the wall around ornaments and different temperature of selected surfaces of detail elements,
- different conductivities of mortar and bricks
- huge heat flux coming through the window surface.

The images obtained by infrared scanning confirmed the results of numerical analysis. The differences in temperature of selected areas can create a several problems like: uneven condensation, deposition of pollutant and unequal aging of selected parts of the wall. By using this method it is possible to quickly obtain the information about potential risk and indicate which element should be especially protected.

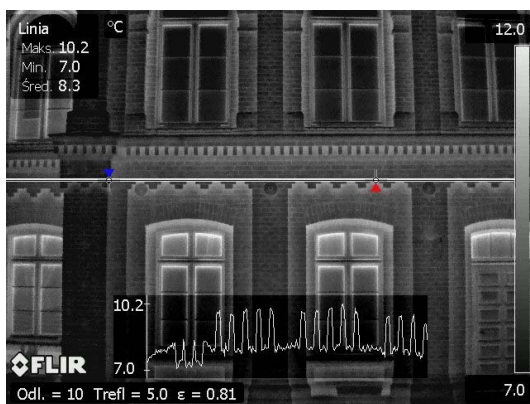
Fig. 10. Results from infrared camera – horizontal temperature profile along the elevation.
