## 652: Applying sustainable renovation policies to buildings: Are we missing a step?

In 1999 an architectural competition was held to select a building design for the new research and technology transfer centre of the School of Architecture of the Vallès in Barcelona. Because of its constructive and architectural characteristics, the winning proposal did not address interior comfort or environmental aspects.

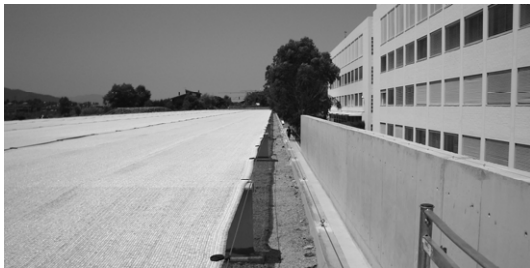
Fig 8. White mesh installed on the roof

A white STR-250 white mesh has been placed on the roof to create 75% shade, as shown in figure 8. Also shown in the photo is the white façade of the nearby building and the exterior

concrete wall that defines the exterior corridor in much of the north façade of the building.

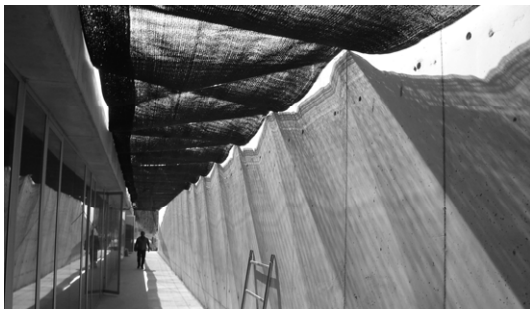
Fig 9. Black mesh installed over exterior corridor on the north façade

Above the north exterior corridor a black STR-250 mesh has been placed to create 80% shade, as in figure 9.
